EXCAVATION OF A FORT FISHER BOMBPROOF

Underwater Archaeology
Branch
Division Of Archives & History
North Carolina Department Of Cultural Resources
Kure Beach, N.C., 1981

EXCAVATION OF A
FORT FISHER
BOMBPROOF

Underwater Archaeology Branch
North Carolina Division of Archives and History

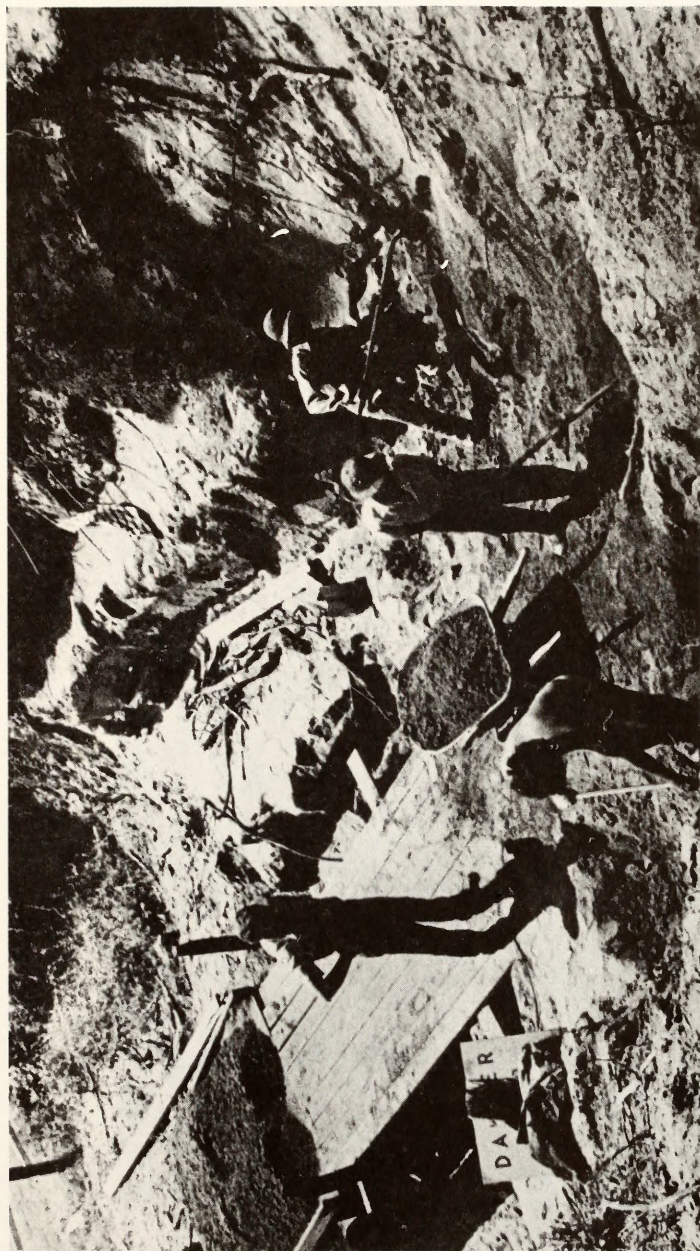
Figure 4. Prior to the availability of mechanical assistance, all overburden was removed by hand. A platform constructed over the bombproof entrance served both to protect the structure and facilitate loading a dump-body trailer designed by Fort Fisher State Historic Site.

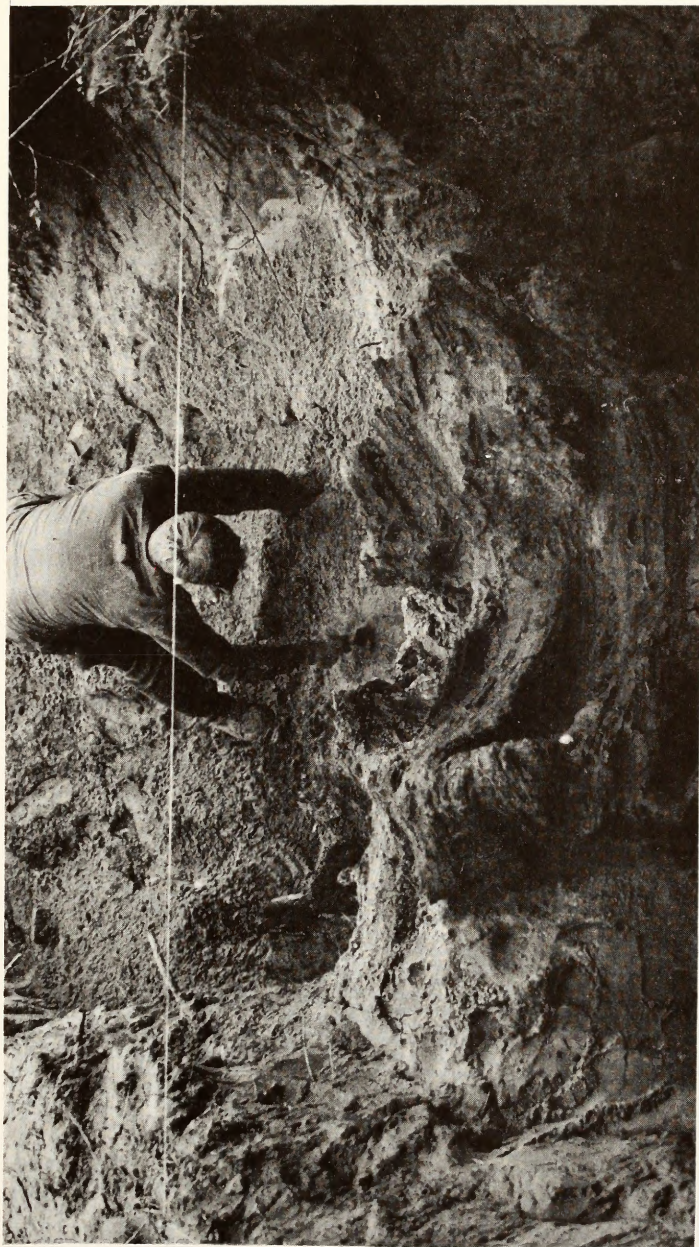
Figure 7. Along the entrance badly deteriorated remains of the roof were found to have sagged but survived to preserve structural data.

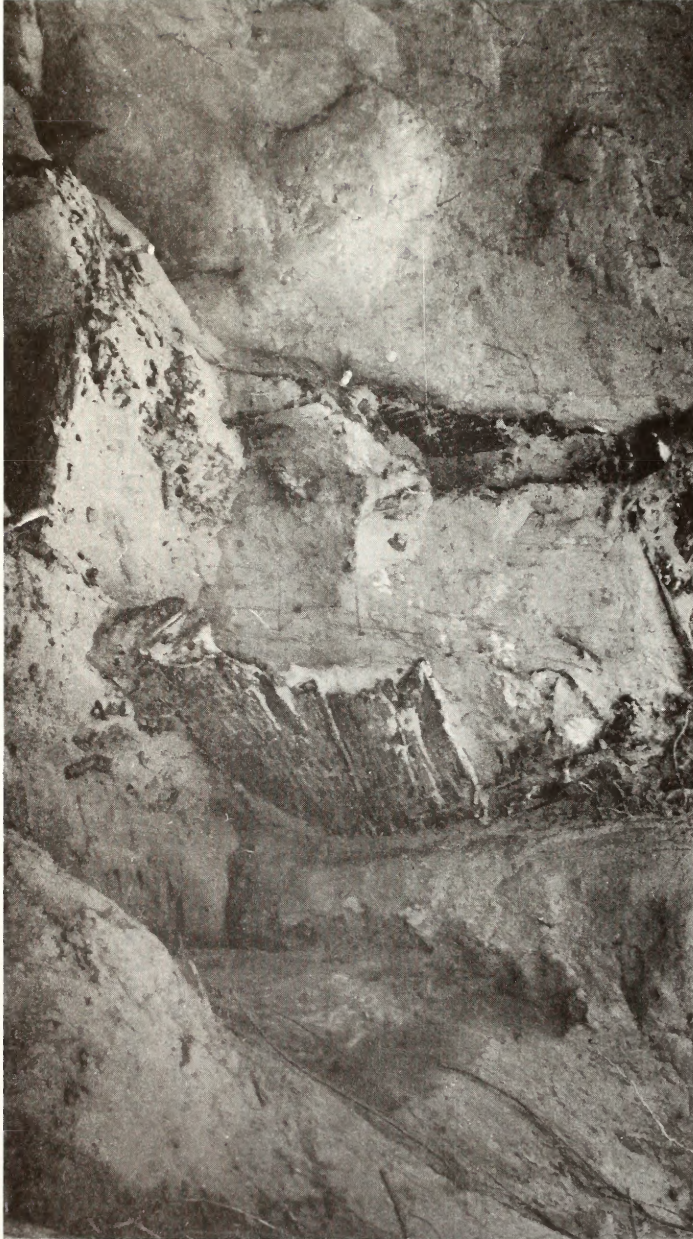
Figure 8. Although partially collapsed, the tunnel structure preserved an extensive record of architectural and construction details.

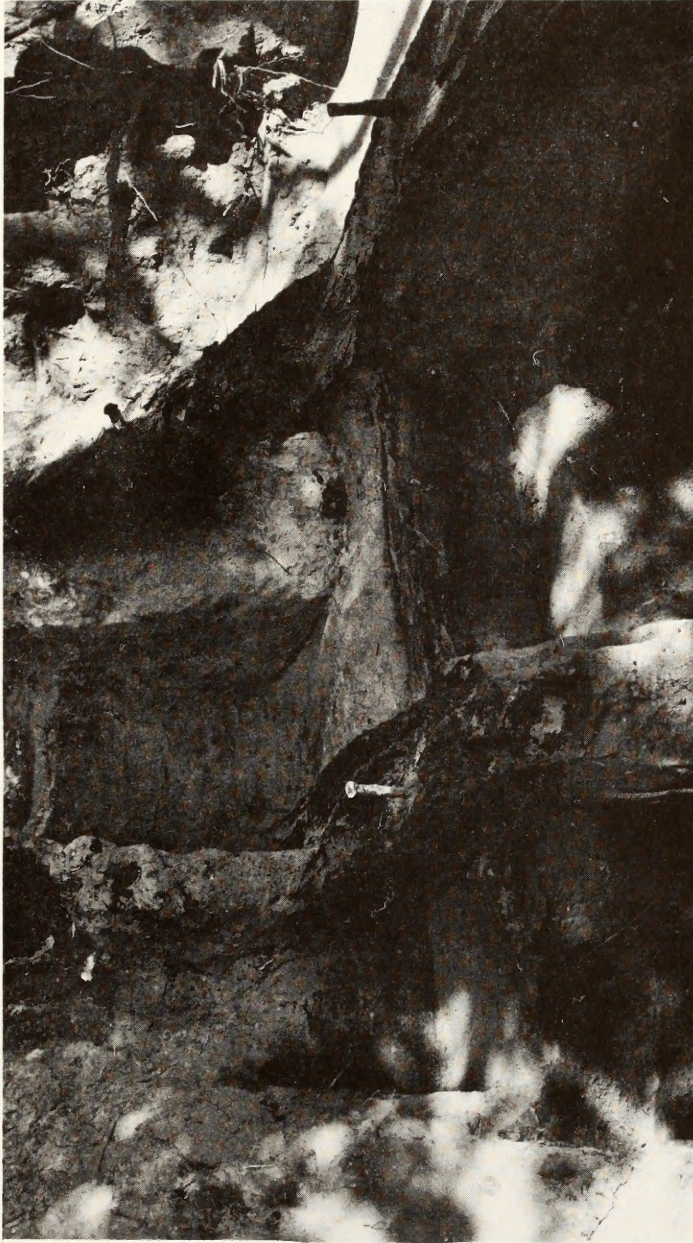
Figure 9. Sills along the entrance section of the bombproof were separated by two spacers
dadoed to accept the sills.

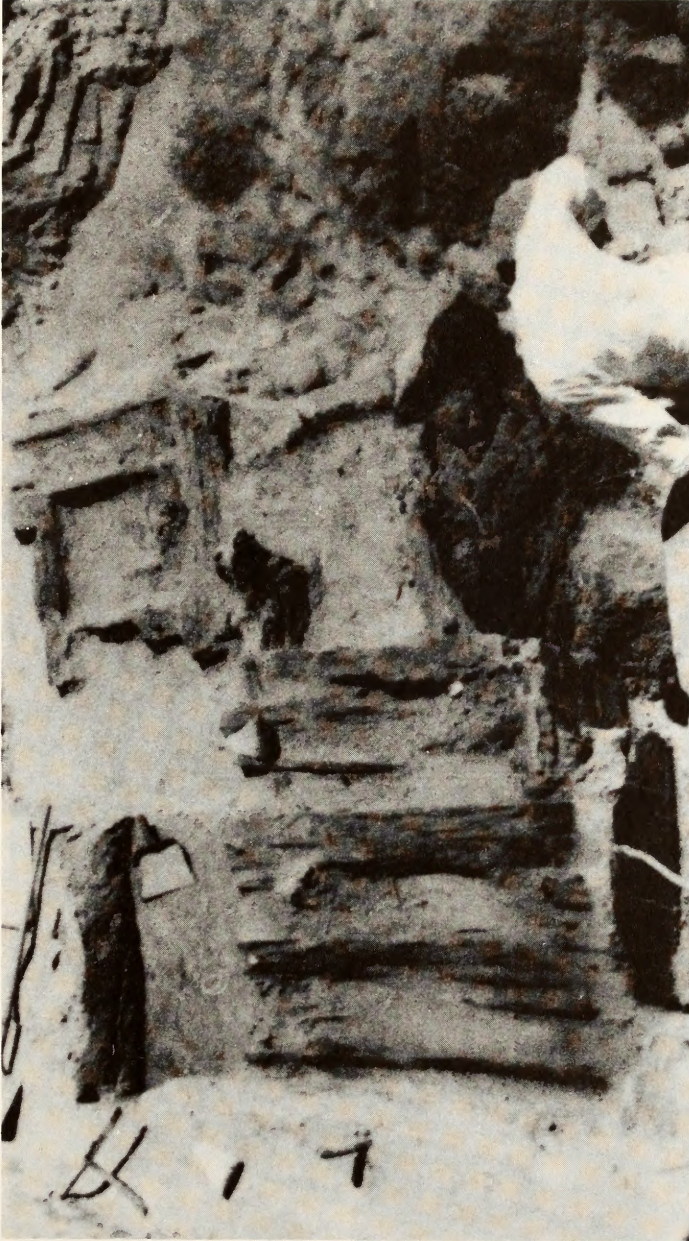
Figure 11. While the majority of the ceiling planking over the baffle was found to have collapsed into the tunnel, evidence indicated that the planks were placed parallel to roof planking along the other sections of the entrance tunnel. The lack of evidence of fastenings in the roof planking confirmed that the weight of backfill was employed to hold the planks in place.

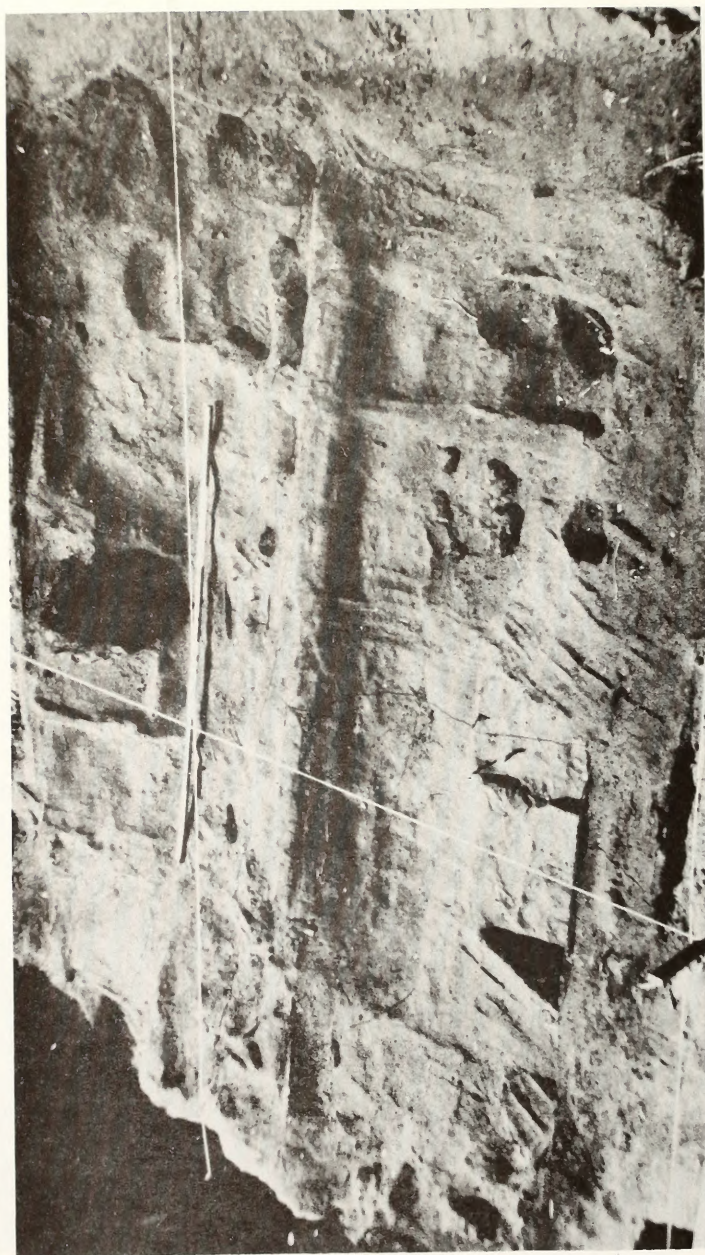
Figure 12. Although collapsed, remains of the bombproof roof preserved evidence of construction feature and a tarred canvas covering.

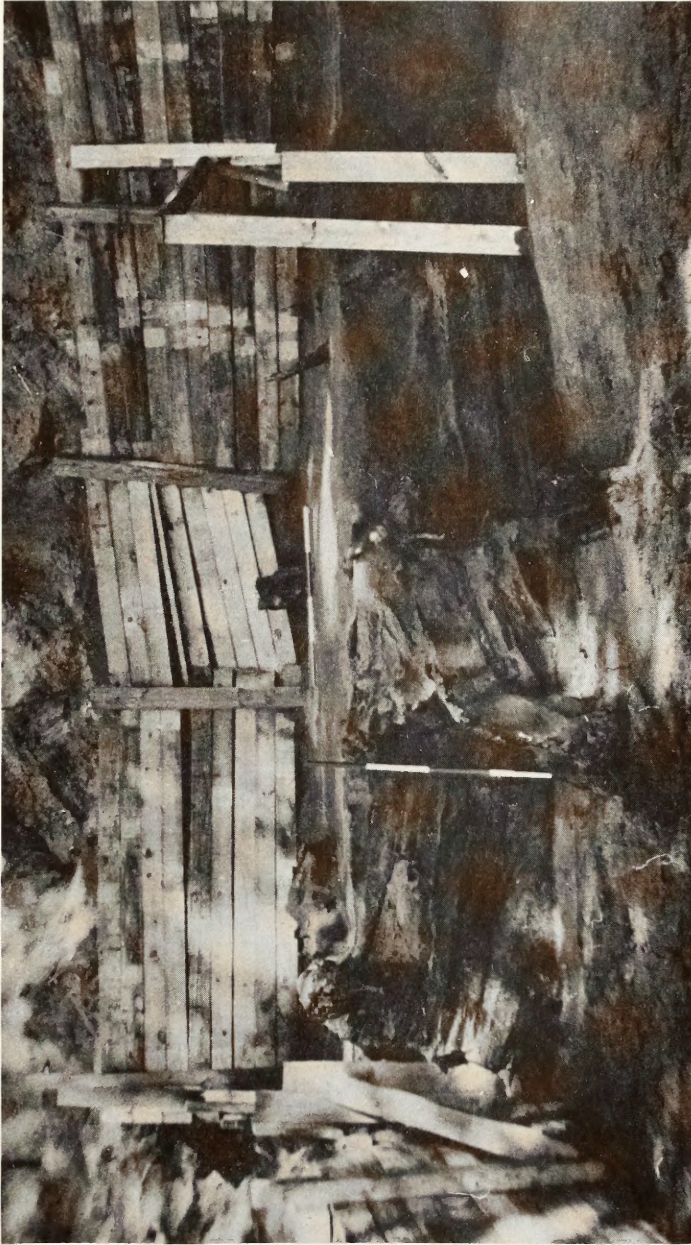
Figure 13. Although the structure had burned and collapsed, sills and portions of the walls of the entrance tunnel and southwest wall of the room remained intact.

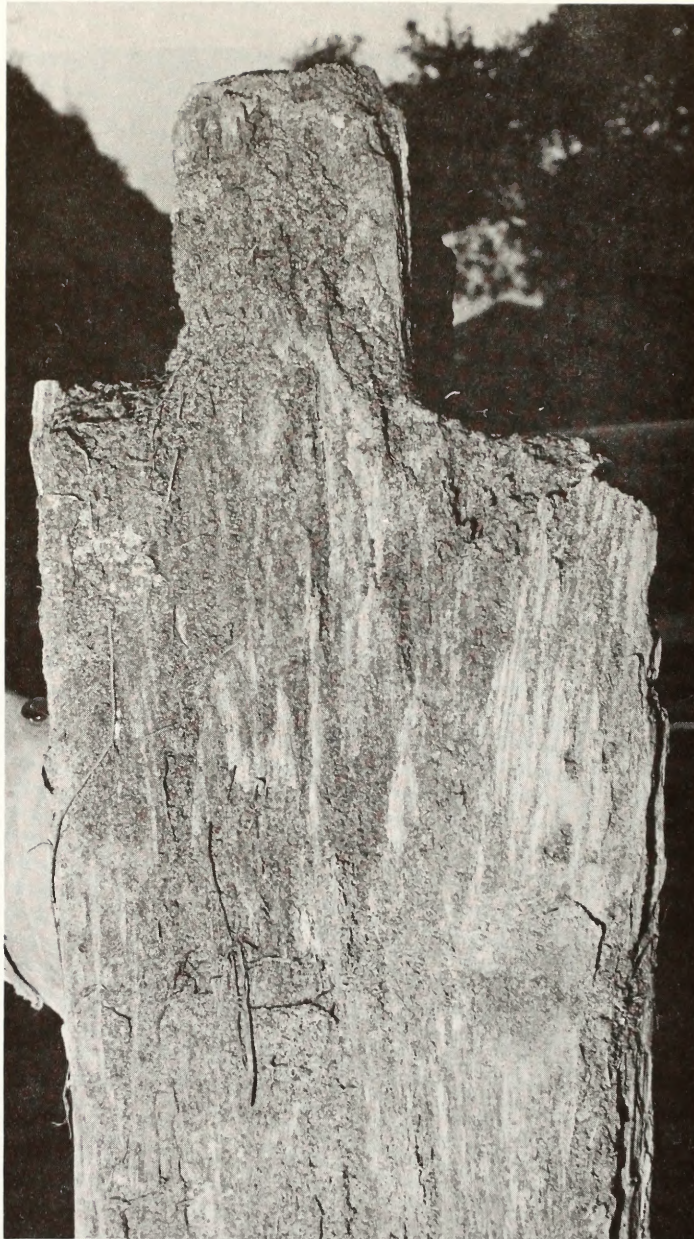
Figure 16. Tenons in the base of the 12-inch by 12-inch studs used in the bombproof wall were found to have been cut on only two sides.

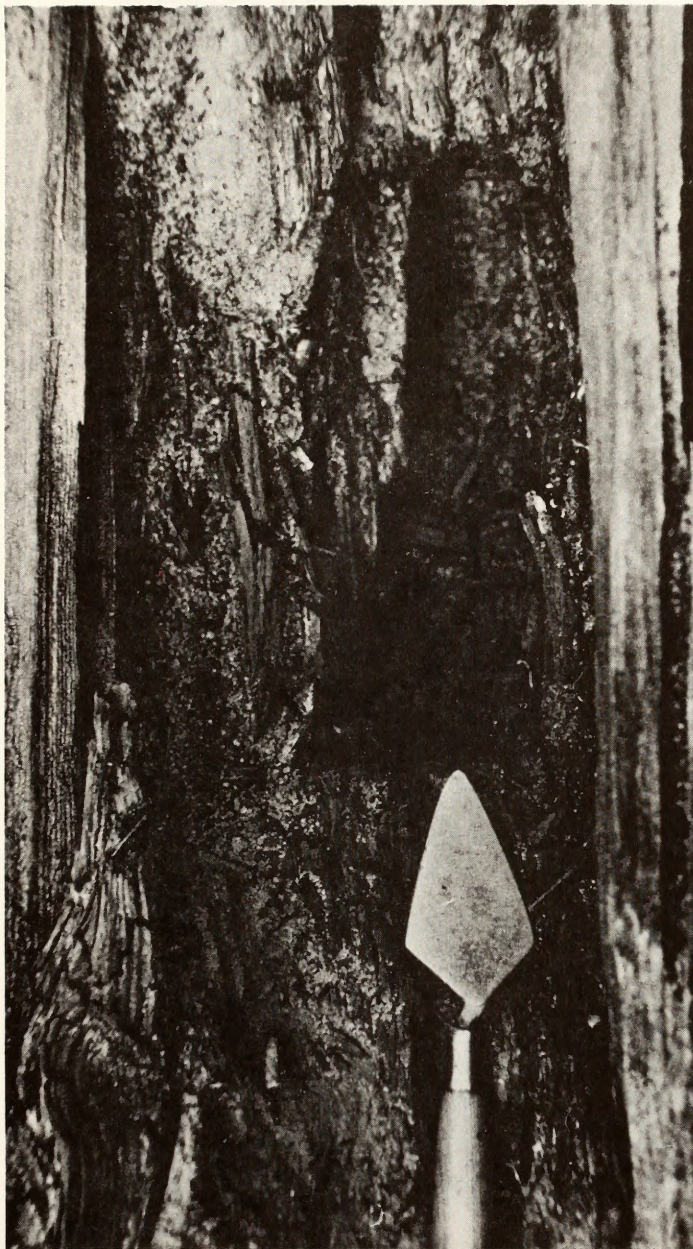
Figure 19. Rectangular mortices for the wall stud tenons were cut 6 inches deep along the longitudinal axis of the sills.

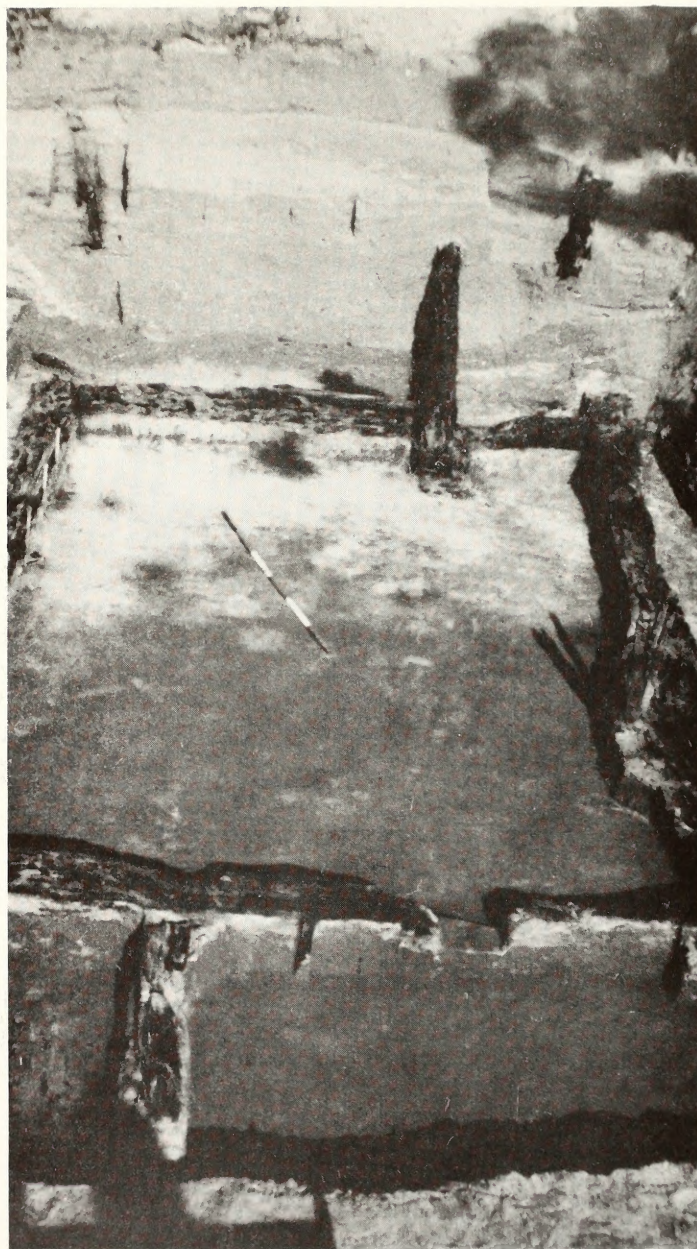
Figure 20. The bombproof sills were cleaned for mapping and photography. Ventilator shafts can be seen in the profile beyond the northeast wall.

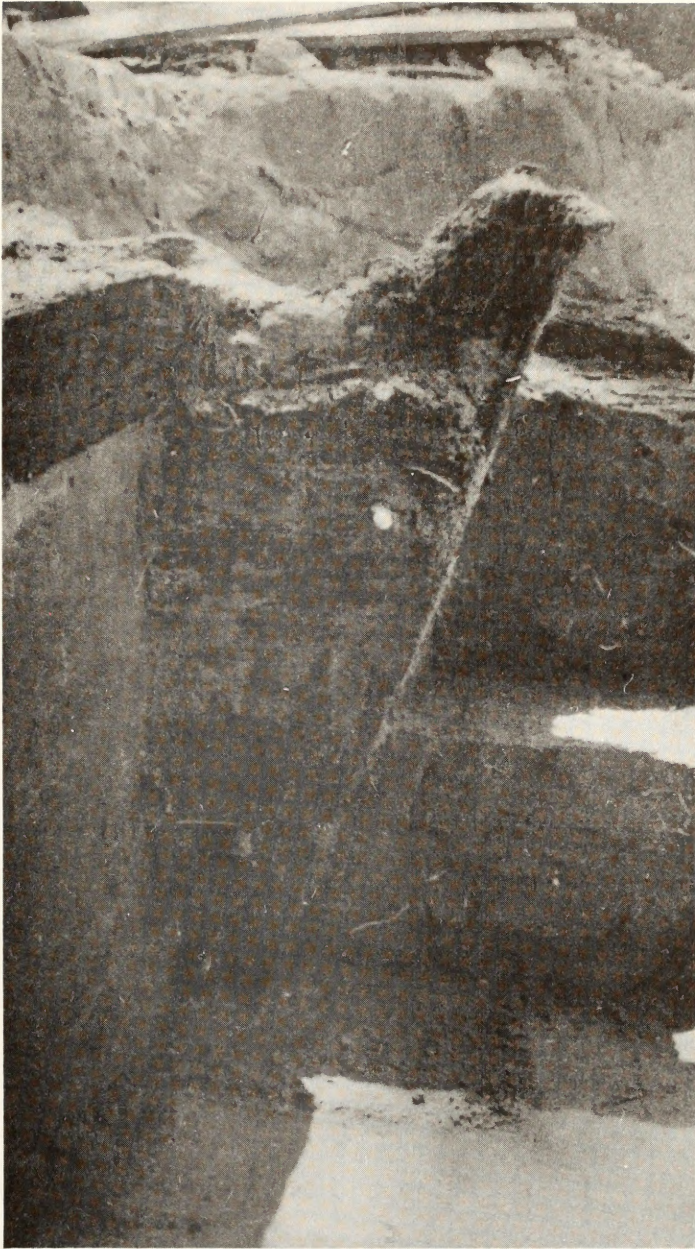
Figure 21. Unmistakable evidence of the interior planking along the tunnel section immediately inside the baffle was found on the east corner post. As was the case along this unusual section, planking was found to be attached at each corner post and studded by one or more 6-inch iron spikes.

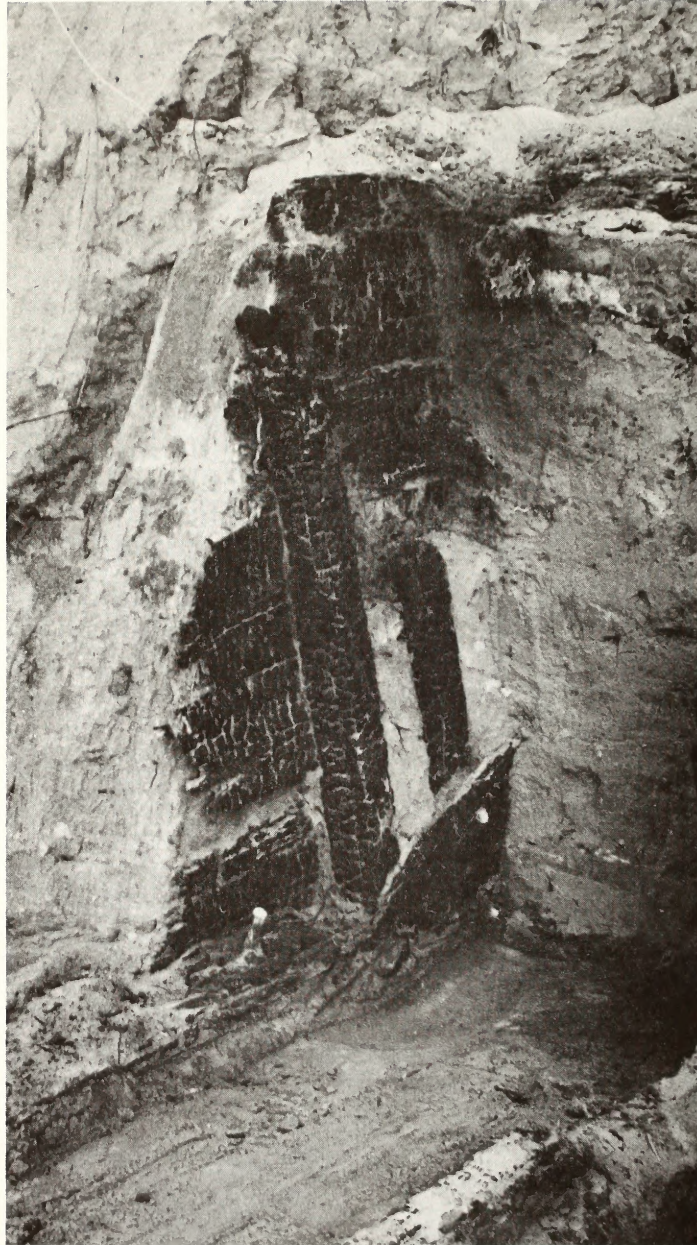
Figure 22. Planks attached diagonally along the entrance sections of the bombproof tunnel were employed to provide increased stability. A pin driven vertically through the sill ahead of the only double stud arrangement in the structure provided evidence that portions of material in the bombproof had been salvaged. Heavy charring confirmed that fire was partially responsible for the destruction of the bombproof.
